WAHOO LAKE DAM
ST. FRANCOIS COUNTY, MISSOURI
MO. 30155

PHASE I INSPECTION REPORT
NATIONAL DAM SAFETY PROGRAM

Name of Dam: Wahoo Lake Dam,
Missouri Inventory No. 30155
State Located: Missouri
County Located: St. Francois
Stream: Unnamed tributary of Bee Run Creek
Date of Inspection: March 6, 1981

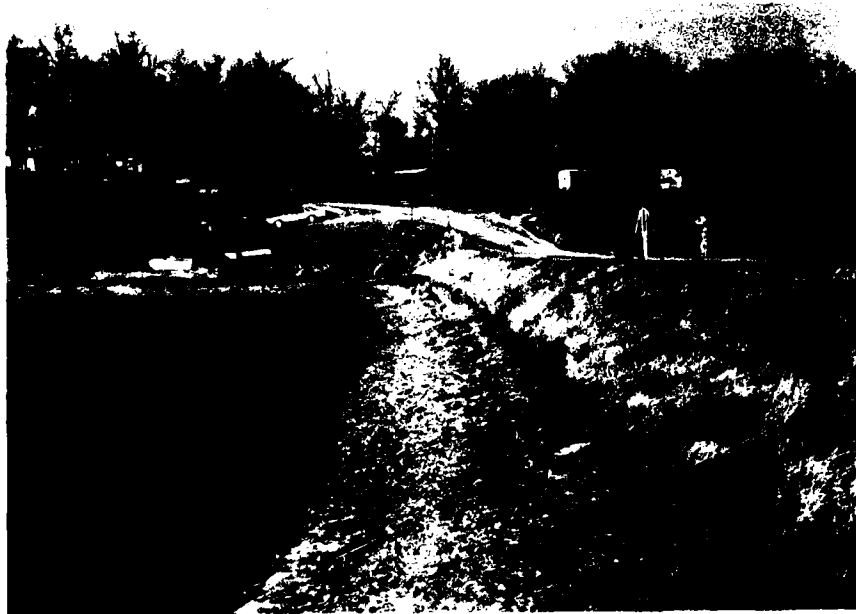
The upstream slope is not protected by riprap; however, a surficial layer of rock fragments was observed on the slope below the normal water surface level (see Photo 1). Some minor erosion and undercutting of the slope due to wave action was observed at the normal water surface level. The undercutting of the slope indicates that future sloughing of the slope is possible. The upper portion of the slope above the normal water surface level was adequately protected against surface runoff by a well maintained grass cover and no erosion due to surface runoff was present. No bulges, depressions or cracks indicating an instability of the embankment or foundation were observed on the slope.

4. The wave erosion on the upstream slope does not appear to affect the stability of the dam in its present condition. However, continual erosion of the slope can only be detrimental to the structural integrity of the dam.

Photo 1 - View of the upstream slope from the right abutment.

5. The wave erosion on the upstream slope should be monitored, and, if the erosion continues, protective measures should be employed to protect the slope from further damage.
